# FLAT SURFACES TO OBTAIN HIGH QUALITY PRODUCTS

Constantinescu Stela

University "Dunarea de Jos" of Galati, Faculty of Materials Engineering and Environment,  
[stela.constantinescu@email.ro](mailto:stela.constantinescu@email.ro)

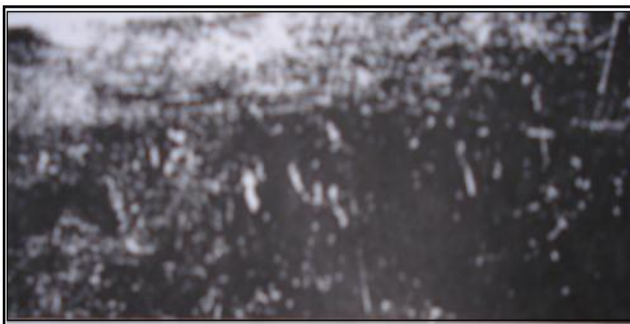
**a) .**

**Figure 6a.** *Traces of roll scale at hot-rolled plate surface*

Roll scale is due to not-observance of heating ranges of slabs in gravity-discharge furnaces when excess-air coefficient exceeds. There are also other reasons such as: inadequate running of the rolling-mill, figure 6a; inadequate descaling; use of defective (burned ) rolls, figure 6b.

avoidance of wear rolls ; avoidance of rolls overheating [15].

Caution : scale formation may avoided through; effective descaling means ; observances of slab heating ranges ; avoidance of slab overheating ; use of rolling mill stand within its working life ;
