THE STRUCTURAL CHANGES TO A ZrO_2 COATING DUE TO CYCLING THERMAL STRESSES

Abstract: Gas turbine aircraft engines are operating under severe thermal, mechanical and chemical conditions. The turbine technology depends on the development of suitable materials that can operate in extreme working environments. Of all the factors acting simultaneously and causing wear, the most important is thermal shock. This paper presents a concept of thermal barrier coating used to prevent exfoliation and increase the maximum working temperature. The coating consist of a $ZrO_2/20\%Y_2O_3$ ceramic layer and a Ni-22wt%Cr-10wt%Al-1wt%Y adherent layer, deposited by atmospheric plasma spraying (APS), on a Ni super alloy sample usually used for the manufacturing of turbine blades. The sample was subjected to thermal shock and after that analyzed. The highlighting and interpretation of the structural changes caused by the thermal shock were made by using modern methods of structural analysis.

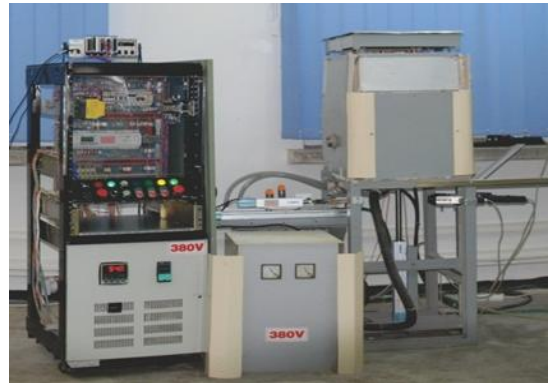
For the thermal shock test in extreme and rapid heating/cooling conditions the QTS2 installation was used. The installation was designed and built by INCAS (National Institute for Aerospace Research "Elie Carafoli") and is presented in Fig.1.

Figure 1: QTS2-Installation for material testing in extreme thermal conditions

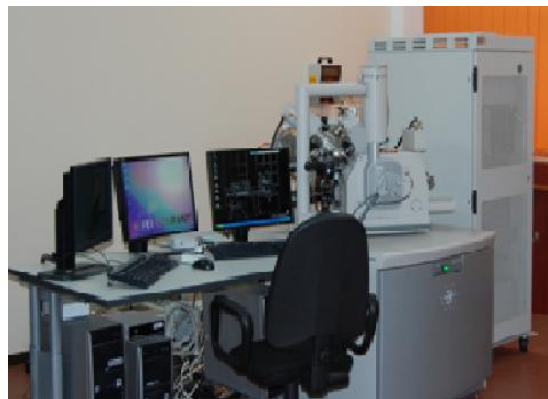
The Quanta 200 3D electron microscope was used to perform secondary electron images and EDAX analysis, working in the Low Vacuum module at pressures ranging from 50 to 60 Pa and using the LFD (Large Field Detector) detector. The voltage used to accelerate the electron beam had the value of 30kV and a working distance varied from 12 to 15 mm, Fig.2.

Figure 2: Quanta 200 3D electron microscope

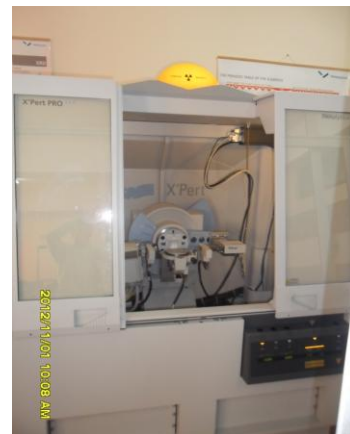
In order to perform a more complete analysis in terms of structural changes due to thermal shock, the ceramic layer was analyzed before and after the test using X-ray diffraction with the X'Pert PRO MRD installation presented in Fig.3.

Figure 3: X'Pert PRO MRD X-ray diffraction installation

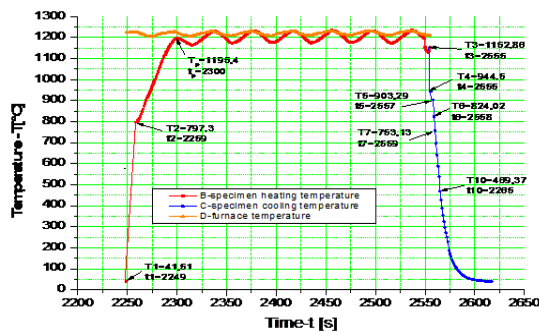
In Fig. 4 is shown the resulting chart after the thermal shock test at a temperature of 1200 °C, and in Fig. 5 the images captured during the heat shock test using the Lab View software.

Figure 4: The chart resulted from the thermal shock test at 1200 °C

The parameters used for the rapid thermal shock test are: the average speed of heating of the sample in the first 10 seconds (75,57 °C/s), the average speed of cooling of the sample in the first 10 seconds (69,34 °C/s) for 60 s of cooling, while maintaining the sample in the oven 5 minutes. The duration of the test is 6 minutes. The maximum pressure of the compressed air during cooling is of 8,7 bar and the minimum pressure has the value of 7,13 bar.

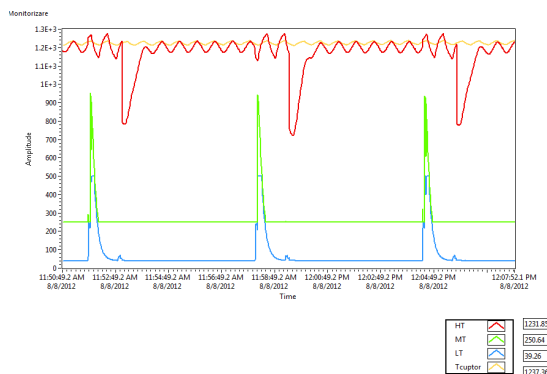
Figure 5: Images captured with the Lab View software during the thermal shock test
