## ENHANCING THE WEAR RESISTANCE OF CAM SURFACES BY A 40CR130 COATING DEPOSITED IN ELECTRIC ARC

**Abstract:** This paper presents the contact fatigue wear behavior of a 40Cr130 metallic coating obtained by electric arc deposition. The coating was deposited on an 18MnCr11 steel alloy. Wear is one of the major failure causes for many component parts from an internal combustion engine. The cams of a camshaft are subjected to wear due to the sliding of contact surfaces in an EHD lubrication regime. The samples were tested on the AMSLER installation for a period of 30 hours to fatigue wear in mixed and limit lubrication conditions. To highlight the results obtained after the test electron microscopy was used. For this purpose the QUANTA 200 3D DUAL BEAM microscope installation was used.

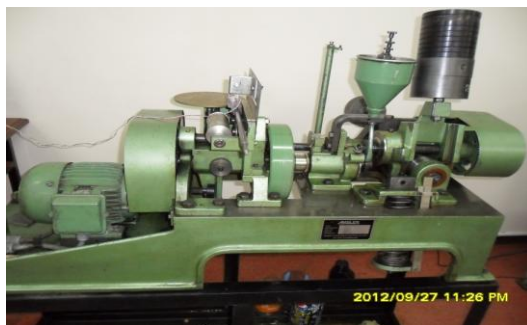
**Figure 2:** The AMSLER contact fatigue installation

For the contact fatigue test the samples had a disc shape with a diameter of 49 mm. The coating was deposited on the rolling side of the disc. The test was done on the AMSLER installation presented in Fig. 2.

In the test one of the samples is static and the other one has a rotational movement around its axis. Different combinations of contact material were used: material base – material base and sample with coating – sample with coating.

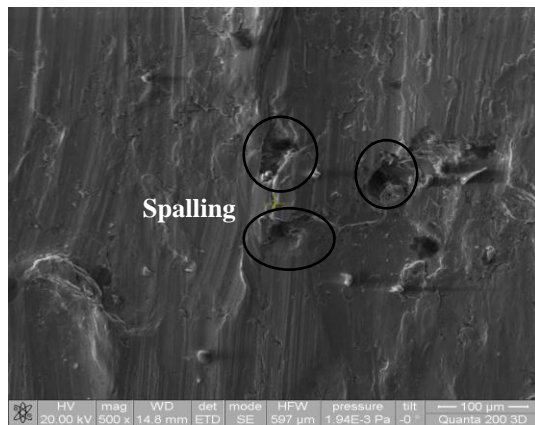
**Figure 4:** Multiple spalling caused by the shear stress

Fig. 4 shows at a magnification of 500X signs of surface failure due to contact fatigue. This fact is highlighted by the presence of multiple spalls. The spalls are produced by cracks which are initiated in the material and propagate to the surface.

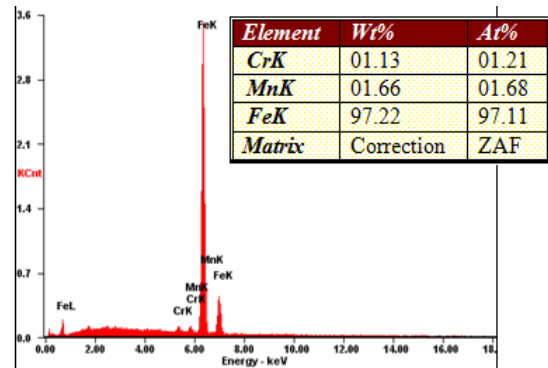
**Figure 6:** Spectral analyses of the 18MnCr11 steel alloy

In fig. 6 is presented the spectral analyses of the base material and the elementary chemical composition.

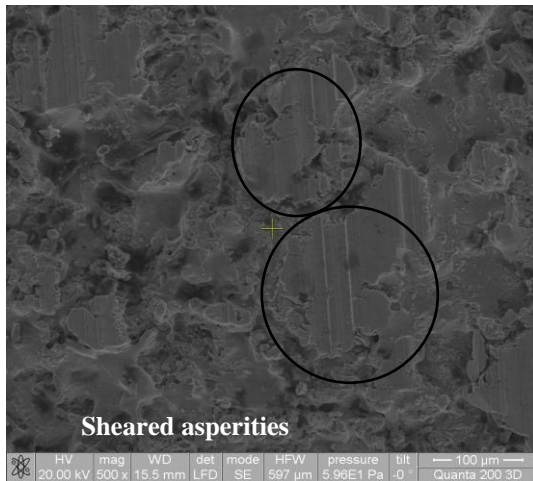
Figure 8: SEM image of the sheared asperities

Fig. 8 shows the sheared asperities after the grinding process of the surfaces to achieve a leveling of the asperities and the nominal working regime. The shearing of the asperities can also indicate the fatigue of the material.

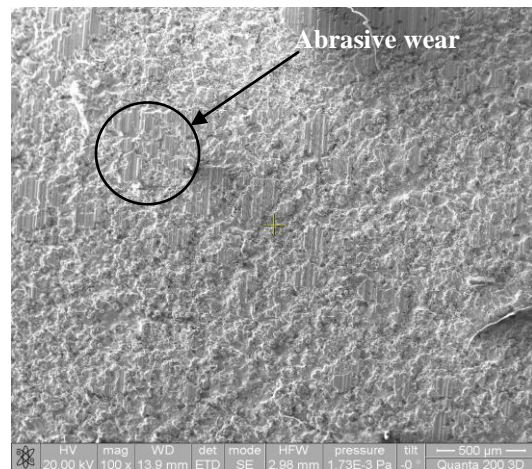
**Figure 15:** SEM image of the rolling surface of the deposited coating

Fig. 15 show a SEM image of the rolling surface of the sample with the 40Cr130 metallic coating subjected to friction in mixed lubricating conditions. The image show abrasion marks due to the shearing of the surface asperities in the grinding process. Fact also presented Fig. 16 at a
